OPTima and Lite

Operator Station Firmware Update CPU V3.2/Comm V1.6 (for use with Kit Number 71-999-J)

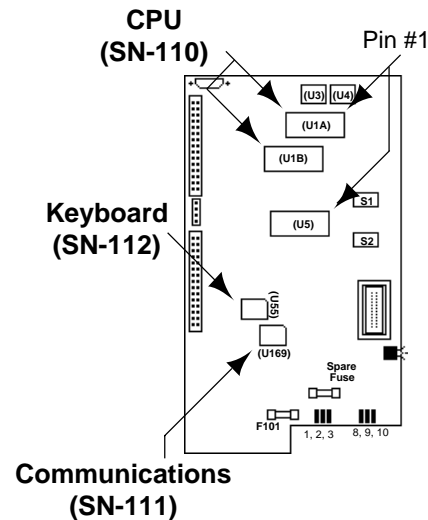
Note that for 128K of memory, U3 is installed. For 256K of memory, U4 is added. For 384K of memory, U5 is added.
